# Manhole Inspection Summary

Manhole # S11UU\_016MH

**Location** Address: **3200 LIBERTY HEIGHTS AVE** Cross Street: **ELLAMONT ROAD**

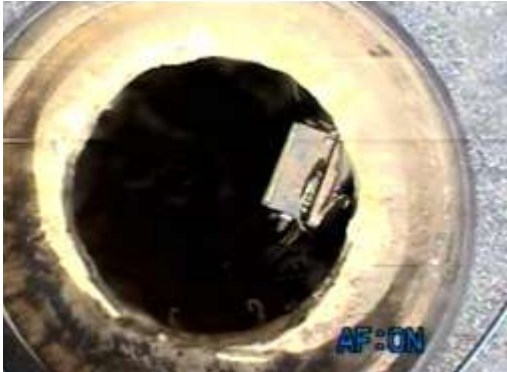
Top View

**Frame** Offset: **4** (in.) Condition: ☒ Sound ☐ Cracked ☐ Leaks

OFFSET

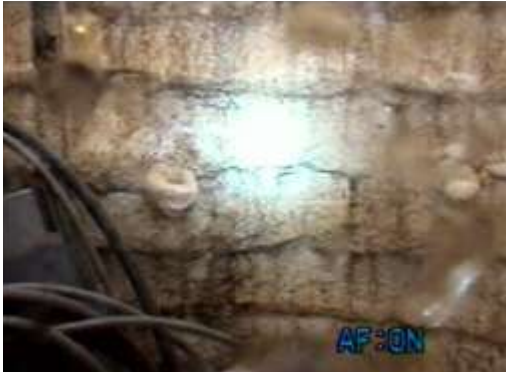
Defect 1

**Steps** Count: **4** Missing: **1** ☐ Corroded

MISSING RUNG

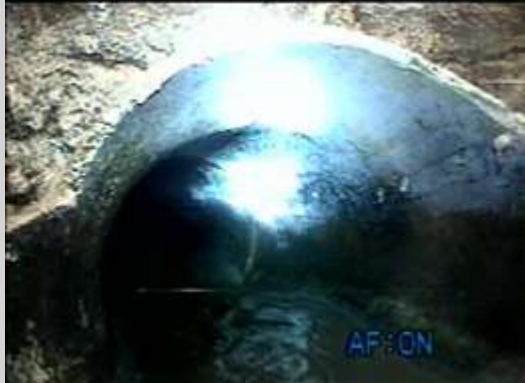
12 O'Clock Outflow

12 in. Circular Gravity Sewer  
Pipe Out @ 12 O'Clock

Pipe Height: (in.) Direct  
Pipe Material: **PVC** ☐ Pipe Lined  
Invert Depth: **9.58** (ft.) Flow Characteristics: **Fast**  
Deposits: ☒ None ☐ Mud ☐ Sludge ☐ Debris ☐ Grease  
Silt Depth: (in.) Deposits Extent:  
Infiltration: **None** Pipe Seal Cond: **Sound**

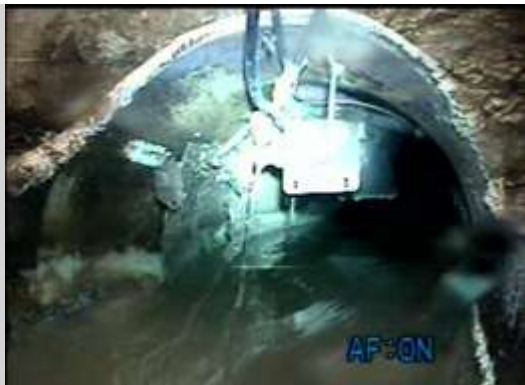
8 O'Clock Inflow

12 in. Circular Gravity Sewer  
Pipe In @ 8 O'Clock

Pipe Height: (in.) Direct  
Pipe Material: **PVC** ☐ Pipe Lined  
Invert Depth: **9.54** (ft.) Flow Characteristics: **Fast**  
Deposits: ☒ None ☐ Mud ☐ Sludge ☐ Debris ☐ Grease  
Silt Depth: (in.) Deposits Extent:  
Infiltration: **None** Pipe Seal Cond: **Sound**
